**Flood Control Project Maintenance
Levee Inspections**

Fall 2016 Levee Maintenance Deficiency Summary Report

Sacramento River Basin

Sutter Maintenance Yard Maintenance Area 0001

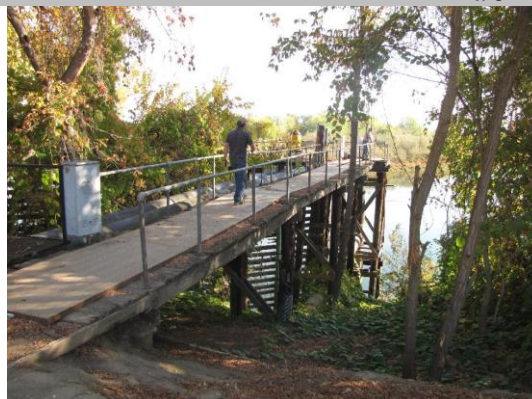
Photo 2 of 2 : UCIP_FA_2016_50494_70245.jpg

Item	DWR UCIP Field Study			39.329749 °	39.329749 °	
				-122.029602 °	-122.029602 °	
DWR ID						
Comment Code						
Inspector Comment						
FS_ID:50494 DS_ID:16453 EP_NO: N/A Repair Type: Urgent Crossing Status: Found UCIP Comments: 10/24/2016 Ws erosion still present. Looks to be just from rain run off.(DWR Sutter Yard- AFreitag)4/25/2016 Erosion still present by the WS pipes. (DWR Sutter Yard - afreitag)4/20/2015 Erosion happening near WS shoulder where the pipes enter the levee. May just be caused by rain runoff. (DWR Sutter Yard - afreitag)6/23/2014 Same as last inspection. (DWR Sutter Yard - afreitag)12/17/2013 Same as last inspection. (DWR Sutter Yard - afreitag)7/18/2013 Same as last inspection. (DWR Sutter Yard - afreitag)10/30/2012 Landward side has been completely altered. Need to find permit for new work. (DWR UCIP - omagana) FIELD_STRUCT_DESC: 24-inch steel pipe through the levee, approximately 15-20 feet below the crown. Gate valve on the waterside (WS) end. Dual 14-inch line visible on the landside (LS). Unable to determine if this is the same crossing as DS_ID 17656. [Additional Reference(s): DWR Levee Log, 1992. USACE Sacramento O&M Manual 137, August 1955, (Station 538+42)]. FS Date: 10/27/2016 1:14:36 PM

Dual 14-inch pipes along catwalk. 24-inch pipe crosses approximately 8 feet below catwalk floor.

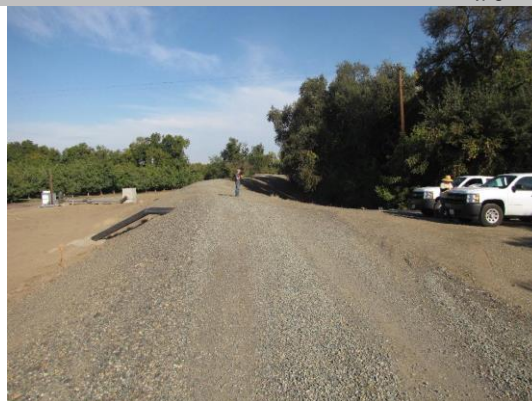
Photo 1 of 2 : UCIP_FA_2016_50495_70236.jpg

FS_ID:50495
DS_ID:16452
EP_NO: 1800
Repair Type: Urgent
Crossing Status: Found
UCIP Comments: 10/24/2016 Ws erosion still present. Looks to be just from rain run off.(DWR Sutter Yard- AFreitag)4/25/2016 Erosion still present by the WS pipes. (DWR Sutter Yard - afreitag)4/20/2015 Erosion happening near WS shoulder where the pipes enter the levee. May just be caused by rain runoff. (DWR Sutter Yard - afreitag)6/23/2014 Same as last inspection. (DWR Sutter Yard - afreitag)12/17/2013 Same as last inspection. (DWR Sutter Yard - afreitag)7/18/2013 Same as last inspection. (DWR Sutter Yard - afreitag)10/30/2012 This crossing has been completely modified--need recent permit issued to allow work on levee and levee toe. Was levee compacted to CVFPB standards? This crossing was listed in the USACE Periodic Inspection as ID# USACE_CESPK_MA1C_2010_p_0371 unable to determine why this crossing was assigned "U". (DWR UCIP - omagana)

Overview of levee crown looking upstream at crossing.

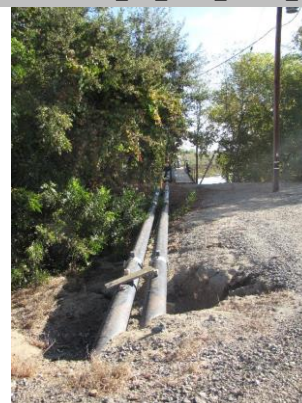
Photo 2 of 2 : UCIP_FA_2016_50495_70235.jpg

View of 2-14 inch crossings through levee on WS.

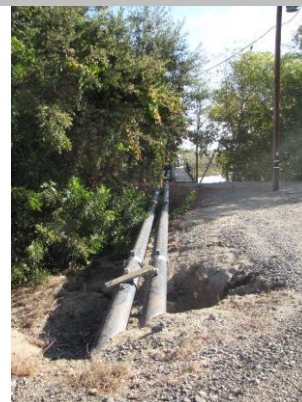
Photo 2 of 2 : UCIP_FA_2016_50496_70227.jpg

FS_ID:50496
DS_ID:17571
EP_NO: 1800
Repair Type: Urgent
Crossing Status: Found
UCIP Comments: 10/24/2016 Ws erosion still present. Looks to be just from rain run off.(DWR Sutter Yard- AFreitag)4/25/2016 Erosion still present near the WS pipes. (DWR Sutter Yard - afreitag)4/20/2015 Erosion happening on WS shoulder near where pipes enter the levee. May just be from rain runoff. (DWR Sutter Yard - afreitag)6/23/2014 Same as last inspection. (DWR Sutter Yard - afreitag)12/17/2013 Same as last inspection. (DWR Sutter Yard - afreitag)7/18/2013 Same as last inspection. (DWR Sutter Yard - afreitag)10/30/2012 This crossing has been completely modified--need recent permit issued to allow work on levee and levee toe. Was levee compacted to CVFPB standards? This crossing was listed in the USACE Periodic Inspection as ID# USACE_CESPK_MA1C_2010_p_0371 unable to determine why this crossing was assigned "U". (DWR UCIP - omagana)

View of WS looking at crossing.

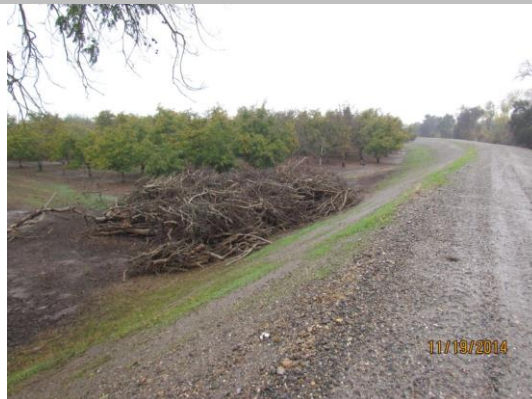
Photo 1 of 1 : FA_2016_MA0001_297_636_20160823_00032.jpg

LM Start	10.32	Rating **	U	Issue No.	636	
LM End	10.32	Issue Type +	En	Location *	LS	
Category	Earthen Levee			GPS Latitude/Longitude		
				Start		End
Item	Encroachments			39.331320 °		39.331320 °
				-122.029932 °		-122.029932 °
DWR ID	DWR_MA0001_01_f_2014_636					
Comment Code						
PR : Prunings						
Inspector Comment						
Remove prunings from the landside toe.

View of the pruning along the landside toe.

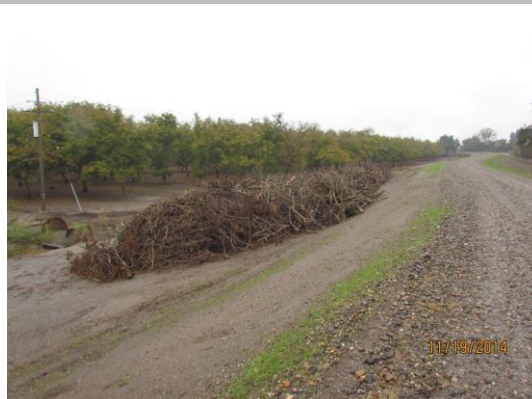
Photo 1 of 1 : FA_2016_MA0001_297_637_20160823_00033.jpg

LM Start	10.78	Rating **	A/W	Issue No.	637
LM End	10.78	Issue Type +	En	Location *	LS
Category	Earthen Levee			GPS Latitude/Longitude	
				Start	End
Item	Encroachments			39.337523 °	39.337523 °
				-122.032437 °	-122.032437 °
DWR ID	DWR_MA0001_01_f_2014_637				
Comment Code					
PR : Prunings					
Inspector Comment

View of the pruning along the landside toe.

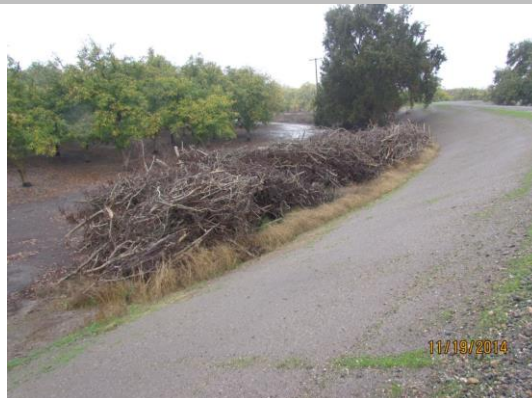
Photo 1 of 1 : FA_2016_MA0001_297_638_20160823_00034.jpg

LM Start	10.96	Rating **	U	Issue No.	638
LM End	10.96	Issue Type +	En	Location *	LS
Category	Earthen Levee			GPS Latitude/Longitude	
				Start	End
Item	Encroachments			39.340217 °	39.340217 °
				-122.032605 °	-122.032605 °
DWR ID	DWR_MA0001_01_f_2014_638				
Comment Code					
PR : Prunings					
Inspector Comment					
Remove prunings from the landside toe.

View of the pruning along the landside toe.

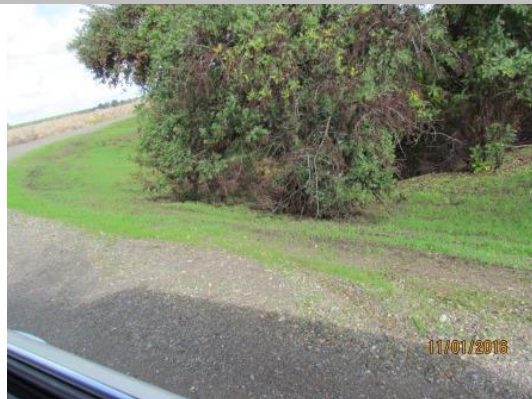
Photo 1 of 1 : FA_2016_MA0001_297_120_20161107_00175.jpg

LM Start	11.00	Rating **	M	Issue No.	120
LM End	11.00	Issue Type +	Ma	Location *	WS
Category	Earthen Levee			GPS Latitude/Longitude	
				Start	End
Item	Trim / Thin Trees			39.340728 °	39.340728 °
				-122.032897 °	-122.032897 °
DWR ID	DWR_MA0001_01_f_2016_120				
Comment Code					
T1 : Trim trees to at least five feet above ground level.					
Inspector Comment

View of the tree with overhanging branches.

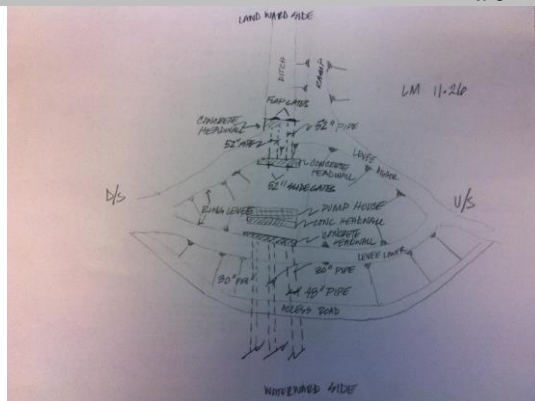
Photo 1 of 2 : UCIP_FA_2016_50501_70267.jpg

FS_ID:50501
DS_ID:16449
EP_NO: 187
Repair Type: Non-Urgent
Crossing Status: Found
UCIP Comments: 10/24/2016 Appears abandoned. Slide gate needs to be dug out and fully closed to prevent water flow during high water.(DWR Sutter Yard- A Freitag)4/25/2016 Crossing appears to be abandoned.4/21/2015 Same as last inspection.6/23/2014 Same as last inspection.12/17/2013 Same as last inspection.7/18/2013 Same as last inspection.10/30/2012 Need to determine if structure is still in use--contact owner. If abandoned structure--structure needs to be properly abandoned. This crossing was listed in the USACE Periodic Inspections as ID# USACE_CESPK_MA1C_2010_p_0393 missing gate. FIELD_STRUCT_DESC: 1 of 2: 52-inch corrugated metal irrigation pipe, 48-inch measured, through the levee, approximately 15 feet below the crown. Slide gate on the waterside (WS) and flap gate on the landside (LS). Concrete headwalls at both WS and LS. This structure is associated with another abandoned structure located on the WS. Abandoned structure includes pump house, multiple concrete walls, and 3 additional crossings (two 30-inch pipes and one 48-inch pipe). (Original structure installed under Permit No. 187, 1921 - Compton-Delevan Irrigation District-Maxwell I.D., new pump and platform installed and old pump house removed under Permit No. 9183-1973, Maxwell Irrigation District) [Additional Reference(s): DWR Levee Log, 1992]. FS Date: 10/27/2016 1:23:08 PM

Sketch of structure located at levee mile 11.26.

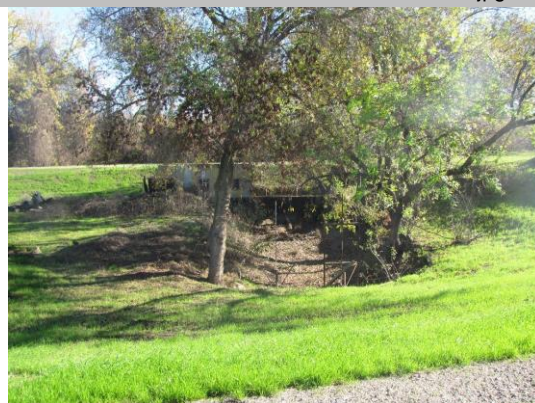
Photo 2 of 2 : UCIP_FA_2016_50501_70265.jpg

View of abandoned structure located on WS (inside ring levee).

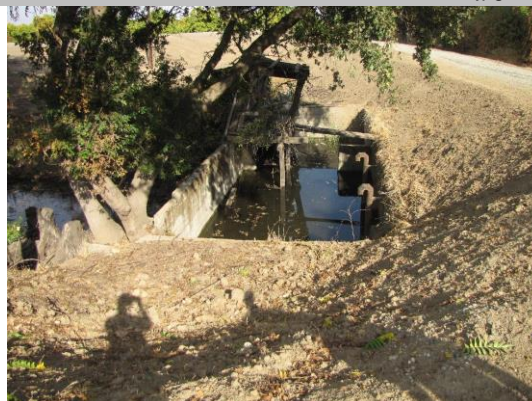
Photo 2 of 2 : UCIP_FA_2016_50502_70276.jpg

FS_ID:50502
DS_ID:17572
EP_NO: 187
Repair Type: Urgent
Crossing Status: Found
UCIP Comments: 10/24/2016 Appears abandoned. Slide gate needs to be replaced or pipe end capped to prevent water flow during high water. (DWR Sutter Yard- AFreitag)4/25/2016 Crossing appears to be abandoned. Slide gate needs to be replaced or pipe needs to be plugged to prevent water flow during high water season. (DWR Sutter Yard - afreitag)4/21/2015 Same as last inspection. (DWR Sutter Yard - afreitag)6/23/2014 Same as last inspection. (DWR Sutter Yard - afreitag)12/17/2013 Same as last inspection. (DWR Sutter Yard - afreitag)7/18/2013 Same as last inspection. (DWR Sutter Yard - afreitag)10/30/2012 Missing positive closure device. Need to determine if structure is still in use--contact owner. If abandoned structure--structure needs to be abandoned properly. This crossing was listed in the USACE Periodic Inspections as ID# USACE_CESPK_MA1C_2010_p_0393 missing gate. (DWR UCIP - omagana)

FIELD_STRUCT_DESC: 2 of 2: 52-inch corrugated metal irrigation pipe, 48-inch measured (2012), through the levee, approximately 15 feet below the crown. Slide gate on the waterside (WS) and flap gate on the landside (LS). Concrete headwalls at both ends. This structure is associated with another abandoned structure located on the WS. Abandoned structure includes pump house, multiple concrete walls, and 3 additional crossings (two 30-inch pipes and one 48-inch pipe). (Original structure installed under Permit No. 187, 1921 - Compton-Delevan Irrigation District-Maxwell I.D., new pump and platform installed and old pump house removed under Permit No. 9183-1973, Maxwell Irrigation District) [Additional Reference(s): DWR Levee Log, 1992].
FS Date: 10/27/2016 1:24:27 PM

Abandoned structure (multiple headwalls and pump structure) located near the lower levee (ring levee).

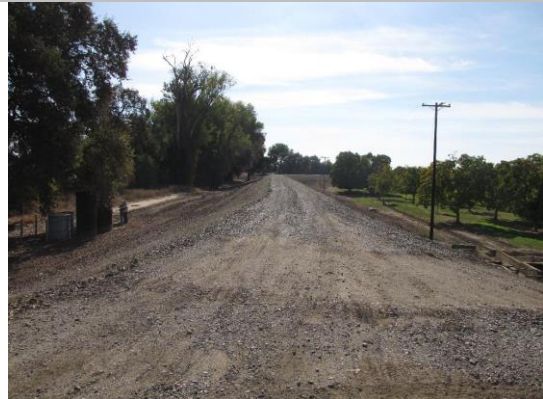
Photo 1 of 2 : UCIP_FA_2016_50504_70327.jpg

FS_ID:50504
DS_ID:17691
EP_NO: 17471
Repair Type: Urgent
Crossing Status: Found
UCIP Comments: 10/24/2016 Sinkhole still present.(DWR Sutter Yard-afreitag)4/25/2016 Sink hole between the standpipes seems to be getting worse. Measurements of the hole are 3' wide x 3' long x 3' deep. The pipe was flowing water and there was water present in the bottom of the sink hole. (DWR Sutter Yard - afreitag)4/21/2015 Sink hole still present between risers. (DWR Sutter Yard - afreitag)6/23/2014 Standing water was present in the bottom of the sinkhole. (DWR Sutter Yard - afreitag)12/17/2013 Same as last inspection. (DWR Sutter Yard - afreitag)7/18/2013 Same as last inspection. (DWR Sutter Yard - afreitag)10/30/2012 Erosion between risers with slide gates located on waterward side; This crossing was listed in the USACE Periodic Inspections as ID# USACE_CESPK_MA1C_2010_p_0398 for possible sinkhole between access gate structures. (DWR UCIP - omagana)

Overview of levee crown looking downstream at crossing.

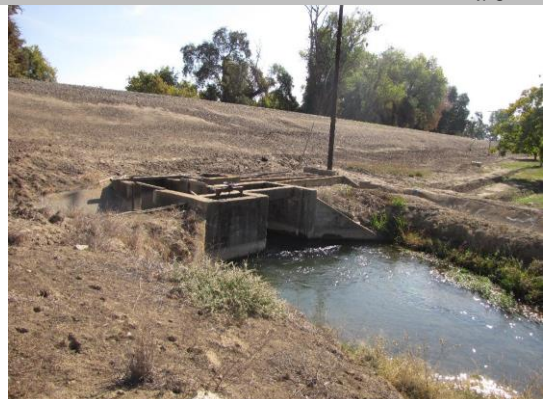
Photo 2 of 2 : UCIP_FA_2016_50504_70326.jpg

View of concrete distribution box located on LS toe.

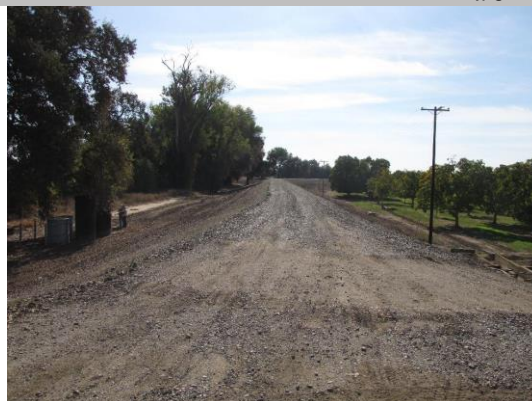
Photo 1 of 2 : UCIP_FA_2016_50505_70325.jpg

FS_ID:50505
DS_ID:17624
EP_NO: 17471
Repair Type: Urgent
Crossing Status: Found
UCIP Comments: 10/24/2016 Sinkhole still present.(DWR Sutter Yard-afreitag)4/25/2016 Sink hole between risers was getting worse (3' wide x 3' long x 3' deep). New smaller sink hole is appearing on the upstream side of this stand pipe (4.5" wide x 20" deep). (DWR Sutter Yard - afreitag)4/21/2015 Sink hole still present between risers. (DWR Sutter Yard - afreitag)6/23/2014 Standing water was present in the bottom of the sinkhole. (DWR Sutter Yard - afreitag)12/17/2013 Same as last inspection. (DWR Sutter Yard - afreitag)7/18/2013 Same as last inspection. (DWR Sutter Yard - afreitag)10/30/2012 Erosion between risers with slide gates located on waterward side; This crossing was listed in the USACE Periodic Inspections as ID# USACE_CESPK_MA1C_2010_p_0398 for possible sinkhole between access gate structures. (DWR UCIP - omagana)

Overview of levee crown looking downstream at crossing.

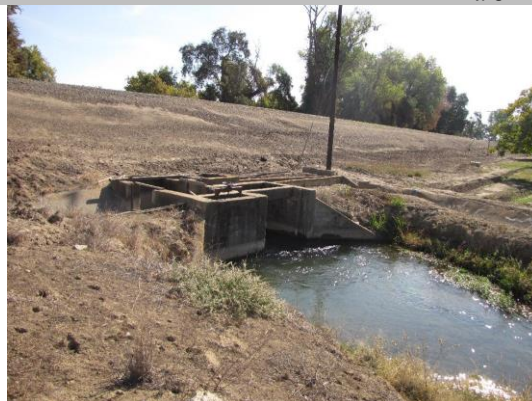
Photo 2 of 2 : UCIP_FA_2016_50505_70324.jpg

View of concrete distribution box located on LS toe.

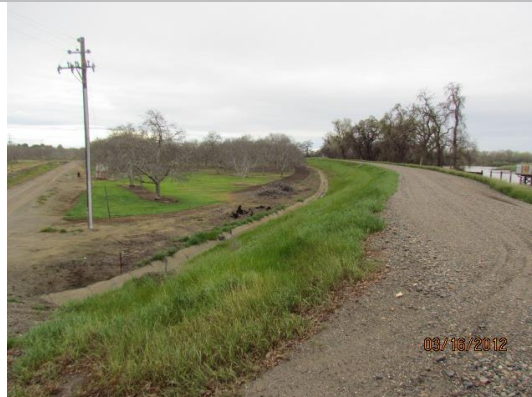
Photo 1 of 1 : FA_2016_MA0001_297_27_20160823_00013.jpg

LM Start	11.21	Rating **	M	Issue No.	27
LM End	11.46	Issue Type +	En	Location *	LS
Category	Earthen Levee			GPS Latitude/Longitude	
				Start	End
Item	Encroachments			39.343542 °	39.347185 °
				-122.032107 °	-122.031525 °
DWR ID	DWR_MA0001_01_s_2012_27				
Comment Code					
DT : Ditch					
Inspector Comment

View of the ag. ditch along the landside toe.

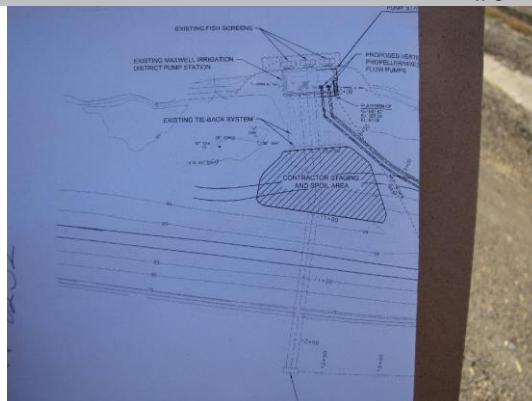
Photo 1 of 2 : UCIP_FA_2016_50509_70331.jpg

Comment Code					
Inspector Comment					
FS_ID:50509					
DS_ID:20582					
EP_NO: N/A					
Repair Type: Non-Urgent					
Crossing Status: Found					
UCIP Comments: 10/24/2016 Appears to be in good condition.(DWR Sutter Yard- A Freitag)4/25/2016 Crossing appears to be in good condition.4/21/2015 Same as last inspection.6/23/2014 Same as last inspection.12/17/2013 Same as last inspection.7/22/2013 Same as last inspection.10/30/2012 Need to determine encroachment permit associated with this crossing.					
FIELD_STRUCT_DESC: [Maxwell Irrigation District] 1 of 3: 24-inch steel irrigation pipe through the levee at an unknown depth below the crown. Crossing is tied to existing Maxwell Irrigation District Pump Station located on the waterside (WS). Siphon breaker inside corrugated metal pipe (CMP) riser located on the landside (LS) shoulder. No permit has been identified since crossing was field discovered in 2012.

Drawing of existing Maxwell Irrigation District Conveyance Pipeline (DWG available through Permit No. 17471 for work located at LM 11.51).

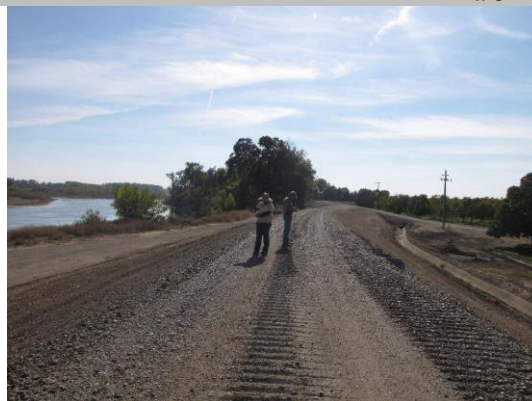
Photo 2 of 2 : UCIP_FA_2016_50509_70333.jpg

Item	DWR UCIP Field Study			39.344376 °	39.344376 °	
				-122.031792 °	-122.031792 °	
DWR ID						
Comment Code						
Inspector Comment						
FS_ID:50509 DS_ID:20582 EP_NO: N/A Repair Type: Non-Urgent Crossing Status: Found UCIP Comments: 10/24/2016 Appears to be in good condition.(DWR Sutter Yard- A Freitag)4/25/2016 Crossing appears to be in good condition.4/21/2015 Same as last inspection.6/23/2014 Same as last inspection.12/17/2013 Same as last inspection.7/22/2013 Same as last inspection.10/30/2012 Need to determine encroachment permit associated with this crossing. FIELD_STRUCT_DESC: [Maxwell Irrigation District] 1 of 3: 24-inch steel irrigation pipe through the levee at an unknown depth below the crown. Crossing is tied to existing Maxwell Irrigation District Pump Station located on the waterside (WS). Siphon breaker inside corrugated metal pipe (CMP) riser located on the landside (LS) shoulder. No permit has been identified since crossing was field discovered in 2012. FS Date: 10/27/2016 1:29:29 PM

Overview of levee crown looking downstream at crossing.

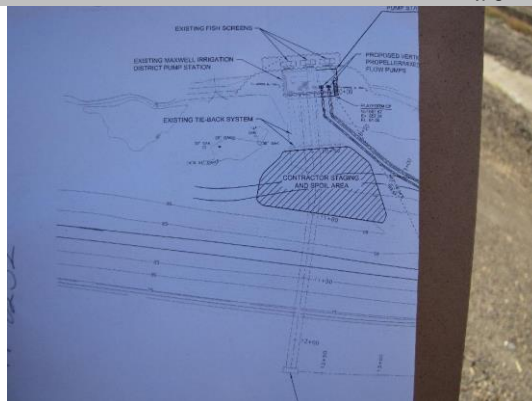
Photo 1 of 2 : UCIP_FA_2016_50510_70337.jpg

FS_ID:50510
DS_ID:20583
EP_NO: N/A
Repair Type: Non-Urgent
Crossing Status: Found
UCIP Comments: 10/24/2016 Appears to be in good condition.(DWR Sutter Yard- AFreitag)4/25/2016 Crossing appears to be in good condition.4/21/2015 Same as last inspection.Need to determine encroachment permit for this crossing.7/22/2013 Same as last inspection.12/17/2013 Same as last inspection.6/23/2014 Same as last inspection.
FIELD_STRUCT_DESC: [Maxwell Irrigation District] 2 of 3: 24-inch steel irrigation pipe through the levee at an unknown depth below the crown. Crossing is tied to existing Maxwell Irrigation District Pump Station located on the waterside (WS). Siphon breaker inside corrugated metal pipe (CMP) riser located on the landside (LS) shoulder. No permit has been identified since crossing was field discovered in 2012.
FS Date: 10/27/2016 1:30:09 PM

Drawing of existing Maxwell Irrigation District Conveyance Pipeline (DWG available through Permit No. 17471 for work located at LM 11.51).

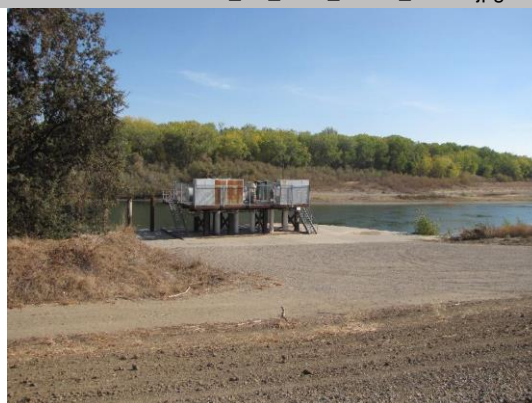
Photo 2 of 2 : UCIP_FA_2016_50510_70338.jpg

Pump Station located on WS.

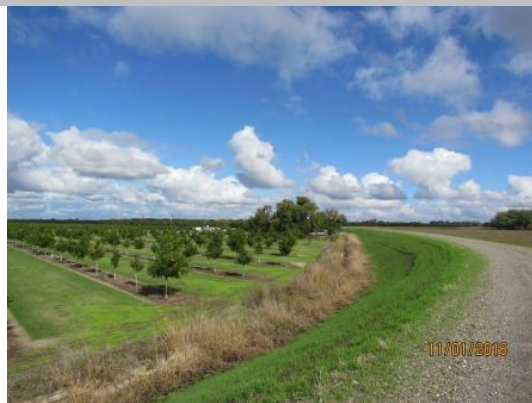
Photo 1 of 1 : FA_2016_MA0001_297_122_20161107_00177.jpg

LM Start	12.24	Rating **	M	Issue No.	122
LM End	12.36	Issue Type +	Ma	Location *	LS
Category	Earthen Levee			GPS Latitude/Longitude	
				Start	End
Item	Vegetation			39.357322 °	39.358283 °
				-122.026590 °	-122.024717 °
DWR ID	DWR_MA0001_01_f_2016_122				
Comment Code					
V1 : Control annual grass and weeds on the levee slopes and easements.					
Inspector Comment

View of the Johnson grass along the levee toe and concrete lined ditch.

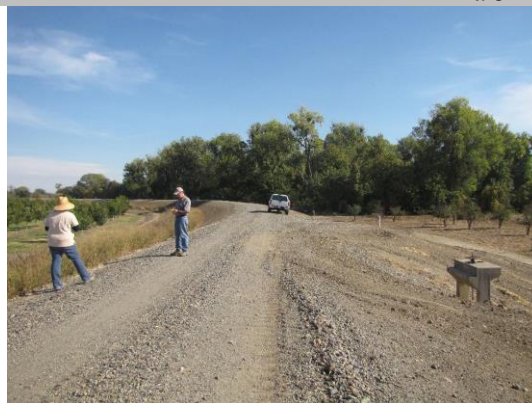
Photo 1 of 2 : UCIP_FA_2016_50514_70352.jpg

Comment Code					
Inspector Comment					
FS_ID:50514 DS_ID:16445 EP_NO: 9462 Repair Type: Non-Urgent Crossing Status: Found UCIP Comments: 10/24/2016 Appears abandoned. LS concrete canal is filled by pipe DSID 16444.4/25/2016 Appears to be an abandoned crossing. WS slide gate still buried and inoperable.4/21/2015 Same as last inspection. 6/23/2014 Same as last inspection.12/17/2013 Same as last inspection.7/22/2013 Same as last inspection.10/30/2012 Slide gate unoperable-blocked by sediment. LS-flap gate missing. 5-inch pipe goes through 24-inch crossing--unable to determine is authorized. This crossing was listed in the USACE Periodic Inspections as ID# USACE_CESPK_MA1C_2010_p_0435 for smaller pipe running inside existing crossing. FIELD_STRUCT_DESC: *ABANDONED* 24-inch corrugated metal drainage pipe through the levee, approximately 10 feet below the crown. Slide gate on both waterside (WS) and landside (LS). Gate missing on the LS. (Automatic Board Order (ABO) issued as Permit No. 9462-1974, Thousand Acre Ranch) [Additional Reference(s): DWR Levee Log, 1992]. FS Date: 10/27/2016 1:32:46 PM

Overview of levee crown looking downstream at crossing.

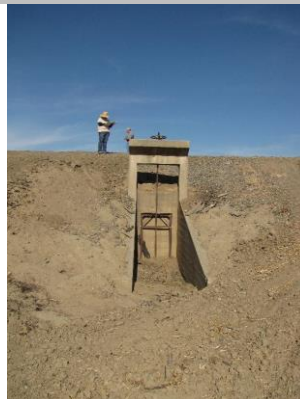
Photo 2 of 2 : UCIP_FA_2016_50514_70351.jpg

Comment Code					
Inspector Comment					
FS_ID:50514 DS_ID:16445 EP_NO: 9462 Repair Type: Non-Urgent Crossing Status: Found UCIP Comments: 10/24/2016 Appears abandoned. LS concrete canal is filled by pipe DSID 16444.4/25/2016 Appears to be an abandoned crossing. WS slide gate still buried and inoperable.4/21/2015 Same as last inspection. 6/23/2014 Same as last inspection.12/17/2013 Same as last inspection.7/22/2013 Same as last inspection.10/30/2012 Slide gate unoperable-blocked by sediment. LS-flap gate missing. 5-inch pipe goes through 24-inch crossing--unable to determine is authorized. This crossing was listed in the USACE Periodic Inspections as ID# USACE_CESPK_MA1C_2010_p_0435 for smaller pipe running inside existing crossing. FIELD_STRUCT_DESC: *ABANDONED* 24-inch corrugated metal drainage pipe through the levee, approximately 10 feet below the crown. Slide gate on both waterside (WS) and landside (LS). Gate missing on the LS. (Automatic Board Order (ABO) issued as Permit No. 9462-1974, Thousand Acre Ranch) [Additional Reference(s): DWR Levee Log, 1992]. FS Date: 10/27/2016 1:32:46 PM

WS concrete structure with slide gate. Gate is blocked by sediment.

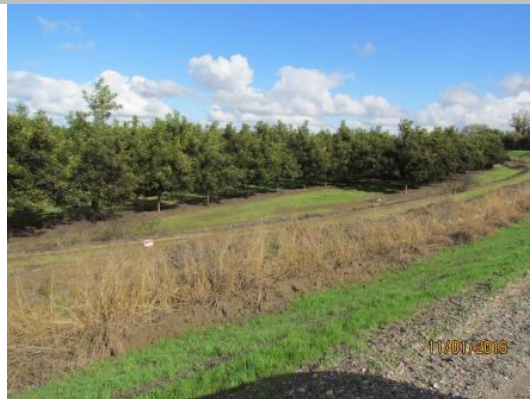
Photo 1 of 1 : FA_2016_MA0001_297_123_20161107_00178.jpg

LM Start	12.69	Rating **	M	Issue No.	123
LM End	12.79	Issue Type +	Ma	Location *	LS
Category	Earthen Levee			GPS Latitude/Longitude	
				Start	End
Item	Vegetation			39.359810 °	39.359748 °
				-122.019402 °	-122.017600 °
DWR ID	DWR_MA0001_01_f_2016_123				
Comment Code					
V1 : Control annual grass and weeds on the levee slopes and easements.					
Inspector Comment

View of the Johnson grass along the levee toe.

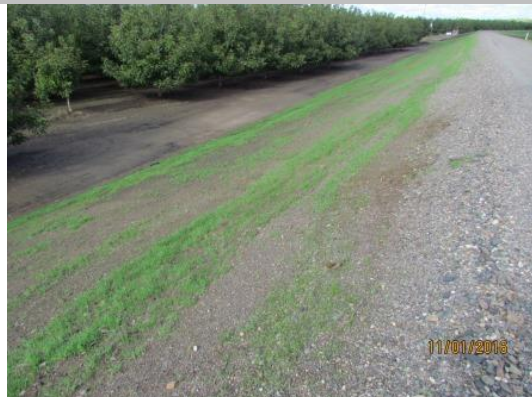
Photo 1 of 1 : FA_2016_MA0001_297_124_20161107_00179.jpg

LM Start	13.33	Rating **	M	Issue No.	124
LM End	13.33	Issue Type +	Ma	Location *	LS
Category	Earthen Levee			GPS Latitude/Longitude	
				Start	End
Item	Slope Stability			39.365748 °	39.365748 °
				-122.015633 °	-122.015633 °
DWR ID	DWR_MA0001_01_f_2016_124				
Comment Code					
S3 : Repair the levee slope damaged by vehicle traffic and prevent access where possible.					
Inspector Comment

View of the slope instability caused by vehicles along the landside slope.

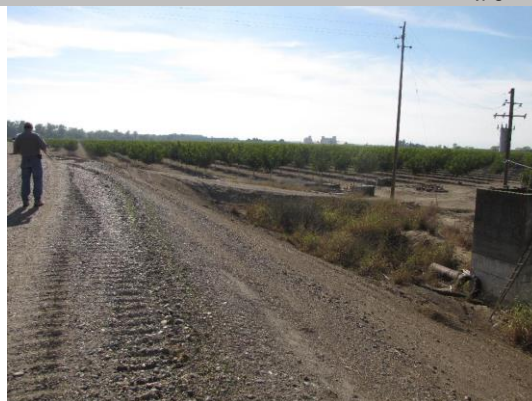
Photo 1 of 2 : UCIP_FA_2016_50683_70377.jpg

FS_ID:50683
DS_ID:16443
EP_NO: 9461
Repair Type: Urgent
Crossing Status: Found
UCIP Comments: 11/01/2016 Erosion/cavity collapse visible on LS toe. Slide gate inside concrete riser located on the WS is in the open position. Need to contact owner to confirm status of crossing and to determine cause of erosion on LS (pipe or concrete box might be leaking). (O. Magana - DWR UCIP)10/24/2016 Appears abandoned.(DWR Sutter Yard- A Freitag)4/25/2016 Slide gate in WS box visually appears to be closed as its stem is all the way down. Still cannot look into box to confirm 100% though. (A. Freitag - DWR Sutter Yard)4/21/2015 Same as last inspection. (A. Freitag - DWR Sutter Yard)6/23/2014 Same as last inspection. (A. Freitag - DWR Sutter Yard)12/17/2013 Same as last inspection. (A. Freitag - DWR Sutter Yard)7/22/2013 Same as last inspection. (A. Freitag - DWR Sutter Yard)10/30/2012 Unable to close positive closure device due to missing ladder-slucce gate inaccessible. Need to determine the condition of the gate. This crossing was listed in the USACE Periodic Inspections as ID# USACE_CESPK_MA1C_2010_p_0453 for an inaccessible gate box with its ladder broken on the waterward side. (O. Magana - DWR UCIP)

View of LS looking downstream at crossing.

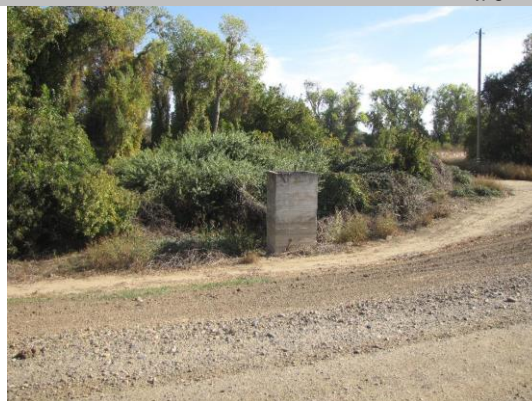
Photo 2 of 2 : UCIP_FA_2016_50683_70376.jpg

FS_ID:50683
DS_ID:16443
EP_NO: 9461
Repair Type: Urgent
Crossing Status: Found
UCIP Comments: 11/01/2016 Erosion/cavity collapse visible on LS toe. Slide gate inside concrete riser located on the WS is in the open position. Need to contact owner to confirm status of crossing and to determine cause of erosion on LS (pipe or concrete box might be leaking). (O. Magana - DWR UCIP)10/24/2016 Appears abandoned.(DWR Sutter Yard- A Freitag)4/25/2016 Slide gate in WS box visually appears to be closed as its stem is all the way down. Still cannot look into box to confirm 100% though. (A. Freitag - DWR Sutter Yard)4/21/2015 Same as last inspection. (A. Freitag - DWR Sutter Yard)6/23/2014 Same as last inspection. (A. Freitag - DWR Sutter Yard)12/17/2013 Same as last inspection. (A. Freitag - DWR Sutter Yard)7/22/2013 Same as last inspection. (A. Freitag - DWR Sutter Yard)10/30/2012 Unable to close positive closure device due to missing ladder-slucce gate inaccessible. Need to determine the condition of the gate. This crossing was listed in the USACE Periodic Inspections as ID# USACE_CESPK_MA1C_2010_p_0453 for an inaccessible gate box with its ladder broken on the waterward side. (O. Magana - DWR UCIP)

View of WS at crossing.

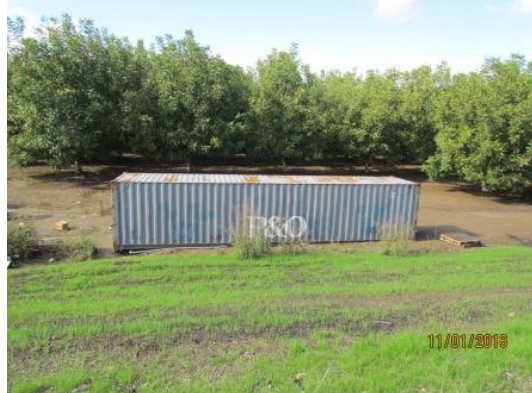
Photo 1 of 1 : FA_2016_MA0001_297_126_20161107_00181.jpg

LM Start	13.48	Rating **	M	Issue No.	126
LM End	13.48	Issue Type +	En	Location *	LS
Category	Earthen Levee			GPS Latitude/Longitude	
				Start	End
Item	Encroachments			39.367832 °	39.367832 °
				-122.015130 °	-122.015130 °
DWR ID	DWR_MA0001_01_f_2016_126				
Comment Code					
EQ : Equipment					
Inspector Comment					
Shipping container stored on landside toe.

View of a shipping container along the landside toe.

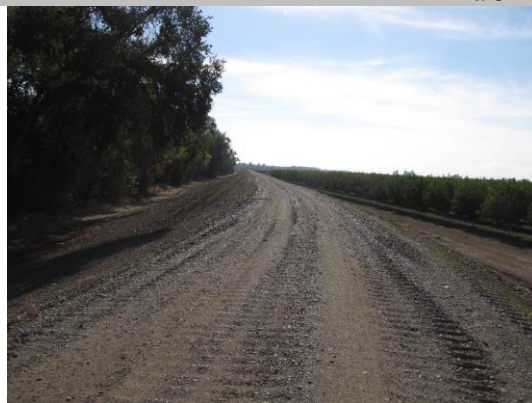
Photo 1 of 2 : UCIP_FA_2016_50521_70379.jpg

Comment Code					
Inspector Comment					
FS_ID:50521 DS_ID:16442 EP_NO: N/A Repair Type: Non-Urgent Crossing Status: Found UCIP Comments: 10/24/2016 Abandoned.(DWR Sutter Yard-AFreitag)4/25/2016 Abandoned crossing4/21/2015 Slide gate is still buried.6/23/2014 Same as last inspection.12/17/2013 Same as last inspection.7/22/2013 Same as last inspection.10/30/2012 Slide gate is buried-non-fuctional. This crossing was listed in the USACE Periodic Inspections as ID# USACE_CESPK_MA1C_2010_p_0457 for buried slide gate. FIELD_STRUCT_DESC: *ABANDONED* 36-inch corrugated metal drainage pipe through the levee at approximately 15-18 feet below the crown. Slide gate on the waterside (WS) end. (Davis Ranches) [Additional Reference(s): DWR Levee Log, 1992]. FS Date: 10/27/2016 1:47:29 PM

Overview of levee crown looking downstream at crossing.

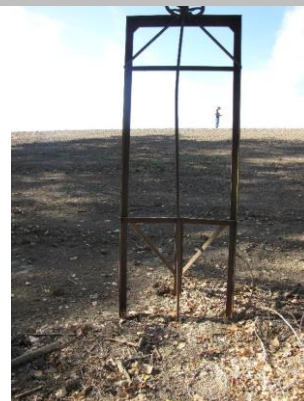
Photo 2 of 2 : UCIP_FA_2016_50521_70380.jpg

Item	DWR UCIP Field Study			39.371934 °	39.371934 °	
				-122.012945 °	-122.012945 °	
DWR ID						
Comment Code						
Inspector Comment						
FS_ID:50521						
DS_ID:16442						
EP_NO: N/A						
Repair Type: Non-Urgent						
Crossing Status: Found						
UCIP Comments: 10/24/2016 Abandoned.(DWR Sutter Yard-AFreitag)4/25/2016 Abandoned crossing4/21/2015 Slide gate is still buried.6/23/2014 Same as last inspection.12/17/2013 Same as last inspection.7/22/2013 Same as last inspection.10/30/2012 Slide gate is buried-non-fuctional. This crossing was listed in the USACE Periodic Inspections as ID# USACE_CESPK_MA1C_2010_p_0457 for buried slide gate.						
FIELD_STRUCT_DESC: *ABANDONED* 36-inch corrugated metal drainage pipe through the levee at approximately 15-18 feet below the crown. Slide gate on the waterside (WS) end. (Davis Ranches) [Additional Reference(s): DWR Levee Log, 1992].						
FS Date: 10/27/2016 1:47:29 PM

WS-Slide gate buried-non-functional.

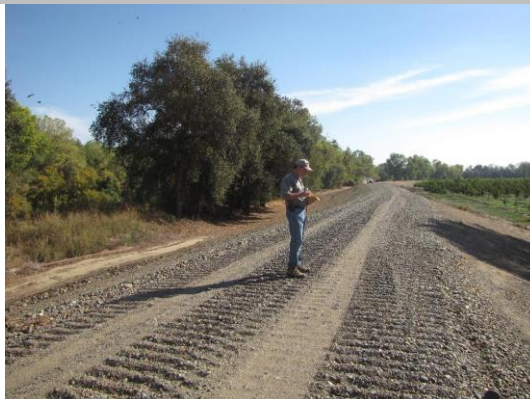
Photo 1 of 2 : UCIP_FA_2016_50523_70383.jpg

FS_ID:50523
DS_ID:16441
EP_NO: 9460
Repair Type: Non-Urgent
Crossing Status: Found
UCIP Comments: 10/24/2016 This entire crossing now appears to be abandoned. The pvc pipe that was previously connected to the LS well pump is no longer connected and used to fill the box.(DWR Sutter Yard-AFreitag)4/25/2016 WS concrete box appears to be abandoned. LS box appears to get filled by a well pump on LS.4/21/2015 Same as last inspection.6/23/2014 Same as last inspection.12/17/2013 Same as last inspection.7/22/2013 Same as last inspection.10/30/2012 Need to determine if crossing is still being used there are some abandoned features that remain at this crossing--crossing has been modified. This crossing was listed in the USACE Periodic Inspections as ID# USACE_CESPK_MA1C_2010_p_0464 for abandoned pump station.
FIELD_STRUCT_DESC: *ABANDONED* 18-inch steel irrigation pipe through the levee, at an unknown depth below the crown. Gate valve on the waterside (WS) end. Pump house on the WS berm. Concrete distribution box and flap gate at the landside (LS) toe. Inspector noted in 2016 that this structure appears to be partially abandoned concrete box appears to be in use. LS box appears to get filled by a well pump located on the LS and water distributed. (Automatic Board Order (ABO) issued as Permit No. 9460, 1974 - Morici Corporation) [Additional Reference(s): DWR Levee Log, 1992].

View of levee crown looking downstream at crossing.

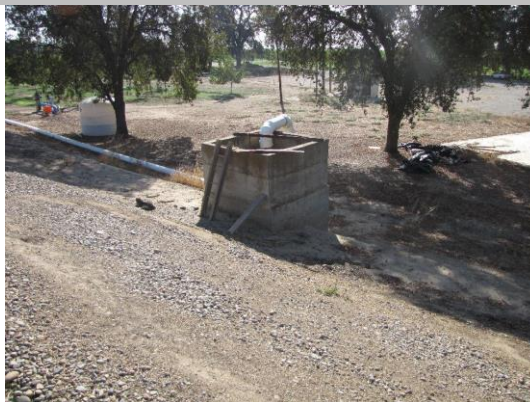
Photo 2 of 2 : UCIP_FA_2016_50523_70382.jpg

Concrete distribution box located on LS toe.

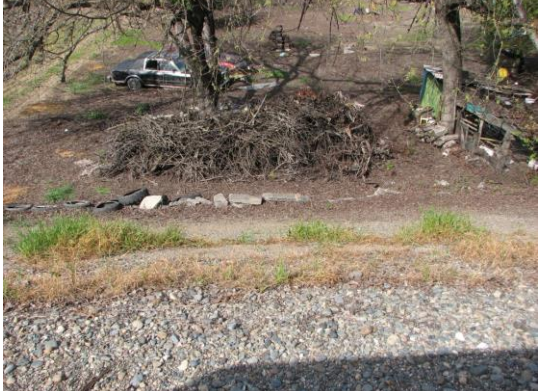
Photo 1 of 1 : FA_2016_MA0001_297_85_20160823_00027.jpg

View of prunings, concrete, and tires along the toe.

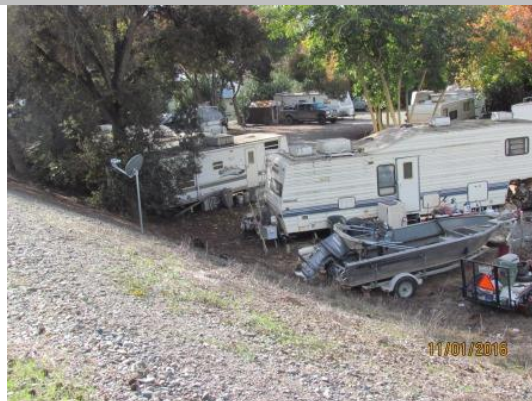
Photo 1 of 1 : FA_2016_MA0001_297_86_20161107_00186.jpg

View of the mobile homes and trailers along the landside toe.

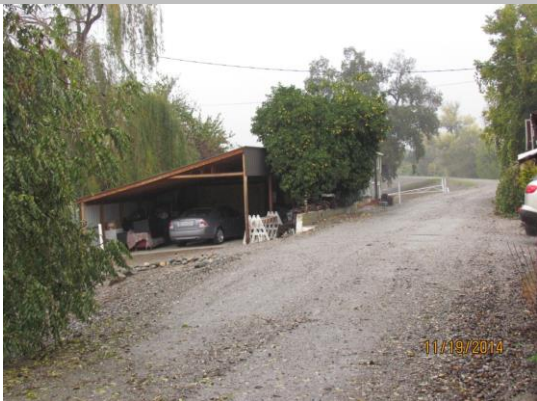
Photo 1 of 1 : FA_2016_MA0001_297_26_20160823_00012.jpg

View of the building on the landside slope.

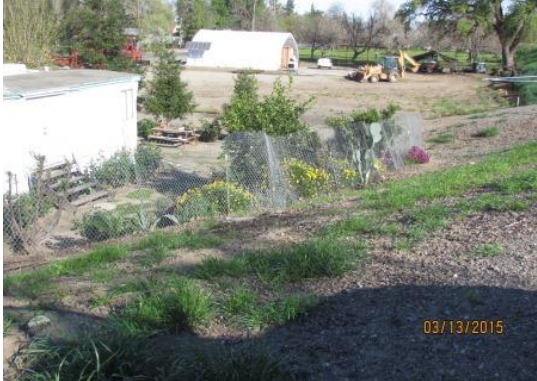
Photo 1 of 1 : FA_2016_MA0001_297_74_20160823_00018.jpg

View of the landscape along the landside slope and toe.

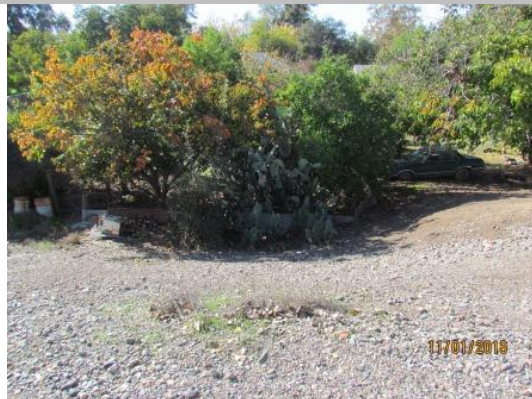
Photo 1 of 1 : FA_2016_MA0001_297_134_20161107_00190.jpg

LM Start	16.26	Rating **	M	Issue No.	134
LM End	16.26	Issue Type +	En	Location *	LS
Category	Earthen Levee			GPS Latitude/Longitude	
				Start	End
Item	Vegetation			39.406520 °	39.406520 °
				-122.008635 °	-122.008635 °
DWR ID	DWR_MA0001_01_f _ 2016_134				
Comment Code					
V6 : Landscaping					
Inspector Comment

View of cactus and fruit trees along the landside toe blocking visibility.

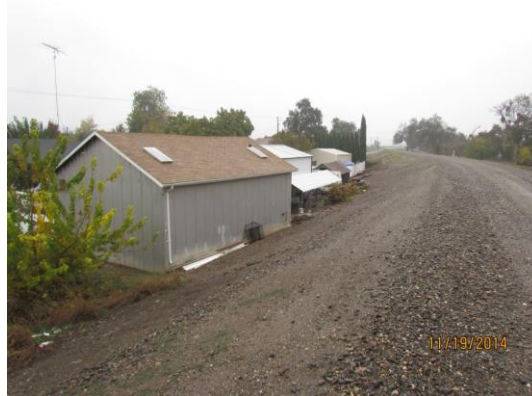
Photo 1 of 1 : FA_2016_MA0001_297_46_20160823_00014.jpg

LM Start	16.31	Rating **	U	Issue No.	46
LM End	16.33	Issue Type +	En	Location *	LS
Category	Earthen Levee			GPS Latitude/Longitude	
				Start	End
Item	Encroachments			39.407225 °	39.407545 °
				-122.008570 °	-122.008640 °
DWR ID	DWR_MA0001_01_s_2012_46				
Comment Code					
BU : Building					
Inspector Comment

View of the building along the landside toe.

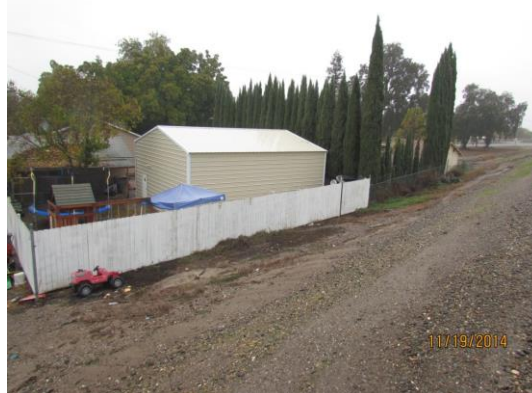
Photo 1 of 1 : FA_2016_MA0001_297_47_20160823_00015.jpg

LM Start	16.34	Rating **	U	Issue No.	47
LM End	16.35	Issue Type +	En	Location *	LS
Category	Earthen Levee			GPS Latitude/Longitude	
				Start	End
Item	Encroachments			39.407670 °	39.407823 °
				-122.008685 °	-122.008740 °
DWR ID	DWR_MA0001_01_s_2012_47				
Comment Code					
FE : Fence					
Inspector Comment

View of the fence along the landside toe.

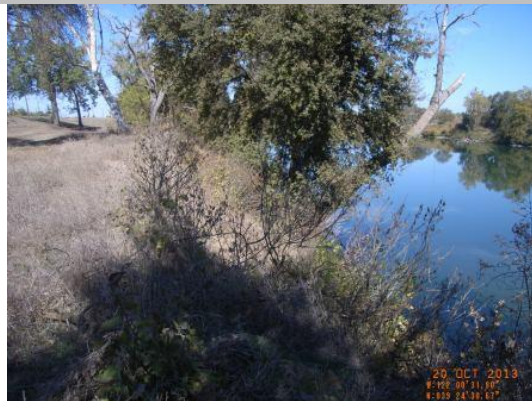
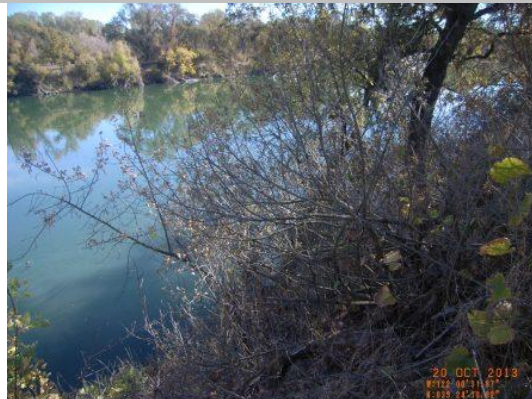
LM Start	16.35	Rating **	M	Issue No.	9
LM End	16.58	Issue Type +	Ma	Location *	WS
Category	Supplemental			GPS Latitude/Longitude	
				Start	End
Item	2015 USACE Erosion Survey, DRAFT			39.407837 °	39.411111 °
				-122.008763 °	-122.009238 °
DWR ID	DWR_MA0001_01_s_2016_9				
Comment Code					
Inspector Comment					
Erosion site added in 1997 and removed in 2005. 2009 - Site added back in, hard toe with slow moving erosion. Potential geotechnical failure. 2011 - Site extended downstream. 2015: Last observed in 2013. [2015 Site ID: SAC_164-3_R]

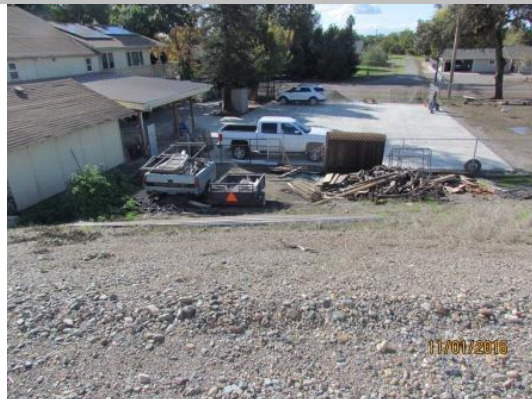
Photo 1 of 1 : FA_2016_MA0001_297_135_20161107_00191.jpg

LM Start	16.37	Rating **	M	Issue No.	135
LM End	16.37	Issue Type +	En	Location *	LS
Category	Earthen Levee			GPS Latitude/Longitude	
				Start	End
Item	Encroachments			39.408073 °	39.408073 °
				-122.009058 °	-122.009058 °
DWR ID	DWR_MA0001_01_f_2016_135				
Comment Code					
EQ : Equipment					
Inspector Comment					
Debris, metal, and firewood on the landside toe.

View of metal sheets along the levee slope and debris and firewood along the landside toe.

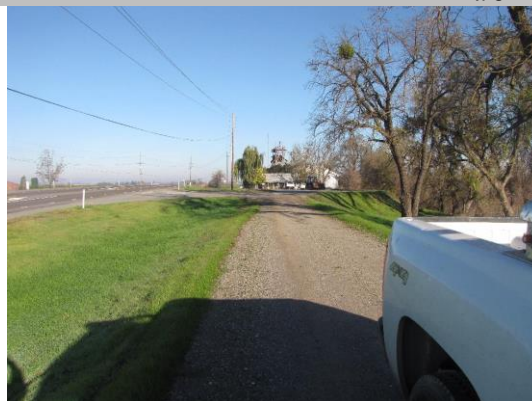
Photo 1 of 2 : UCIP_FA_2016_50527_70391.jpg

Comment Code					
Inspector Comment					
<p>FS_ID:50527 DS_ID:16448 EP_NO: 14424 Repair Type: Non-Urgent Crossing Status: Found UCIP Comments: 10/24/2016 WS marker sign still knocked over.(DWR Sutter Yard- AFreitag)4/25/2016 WS marker sign is still knocked over.4/21/2015 Same as last inspection.11/3/2014 (DWR-Olivia) Need to contact owner to determine when markers will be placed.</p> <p>6/23/2014 Same as last inspection.12/17/2013 Same as last inspection.7/22/2013 Same as last inspection.12/2012 Waiting for information regarding crossing from PG&E. Regarding damage warning sign--PG&E has initiated a project to replace pipeline crossing sign and utility markers, as required by DOT codes/regulations.11/2012 Utility warning sign damaged. Olivia (UCIP team) is coordinating with PG&E to determine more info on crossing.</p> <p>FIELD_STRUCT_DESC: 12-inch gas pipe through the levee, 30-inches below the crown. This 12-inch replacement pipe was installed by horizontally directionally drilling under the State HWY. Crossing is cathodically protected against external corrosion. Line was bored with a minimum cover of 48 feet under the right bank levee, 60 feet under the right bank, 25 feet under the channel and 52 feet under the left bank. Emergency contact: Monte Penland, Gas Maintenance Supervisor, 15871 Central Street, Meridian, CA 95957; Office No. 530-634-6520 or Mobile No. 530-356-7396. Utility crossing coordinates are approximate. This pipe is under pressure and cathodic protection (CP) readings are taken on a regular schedule. (Permit No. 14424, 1988 - Pacific Gas & Electric [PG&E]) [Additional Reference(s): DWR Levee Log, 1992]. FS Date: 10/27/2016 1:51:29 PM</p>

View just upstream of utility crossing.

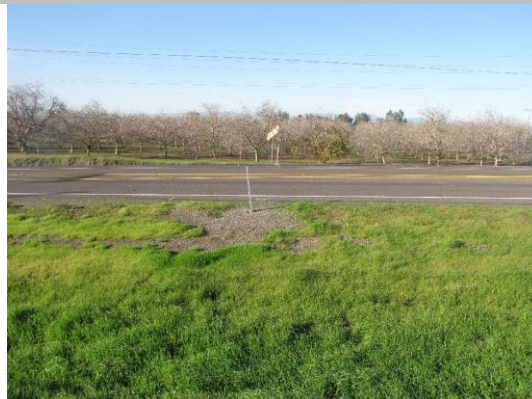
Photo 2 of 2 : UCIP_FA_2016_50527_70390.jpg

Item	DWR UCIP Field Study			39.410645 °		39.410645 °
				-122.009705 °		-122.009705 °
DWR ID						
Comment Code						
Inspector Comment						
<p>FS_ID:50527 DS_ID:16448 EP_NO: 14424 Repair Type: Non-Urgent Crossing Status: Found UCIP Comments: 10/24/2016 WS marker sign still knocked over.(DWR Sutter Yard- AFreitag)4/25/2016 WS marker sign is still knocked over.4/21/2015 Same as last inspection.11/3/2014 (DWR-Olivia) Need to contact owner to determine when markers will be placed.</p> <p>6/23/2014 Same as last inspection.12/17/2013 Same as last inspection7/22/2013 Same as last inspection.12/2012 Waiting for information regarding crossing from PG&E. Regarding damage warning sign--PG&E has initiated a project to replace pipeline crossing sign and utility markers, as required by DOT codes/regulations.11/2012 Utility warning sign damaged. Olivia (UCIP team) is coordinating with PG&E to determine more info on crossing.</p> <p>FIELD_STRUCT_DESC: 12-inch gas pipe through the levee, 30-inches below the crown. This 12-inch replacement pipe was installed by horizontally directionally drilling under the State HWY. Crossing is cathodically protected against external corrosion. Line was bored with a minimum cover of 48 feet under the right bank levee, 60 feet under the right bank, 25 feet under the channel and 52 feet under the left bank. Emergency contact: Monte Penland, Gas Maintenance Supervisor, 15871 Central Street, Meridian, CA 95957; Office No. 530-634-6520 or Mobile No. 530-356-7396. Utility crossing coordinates are approximate. This pipe is under pressure and cathodic protection (CP) readings are taken on a regular schedule. (Permit No. 14424, 1988 - Pacific Gas & Electric [PG&E]) [Additional Reference(s): DWR Levee Log, 1992]. FS Date: 10/27/2016 1:51:29 PM</p>

View of utility marker located on LS across hwy.
